OnSight PROS Report Professional Documentation http://www.onsightpros.com

Address: 123 Main St.

Type of Inspection: Periodic Report

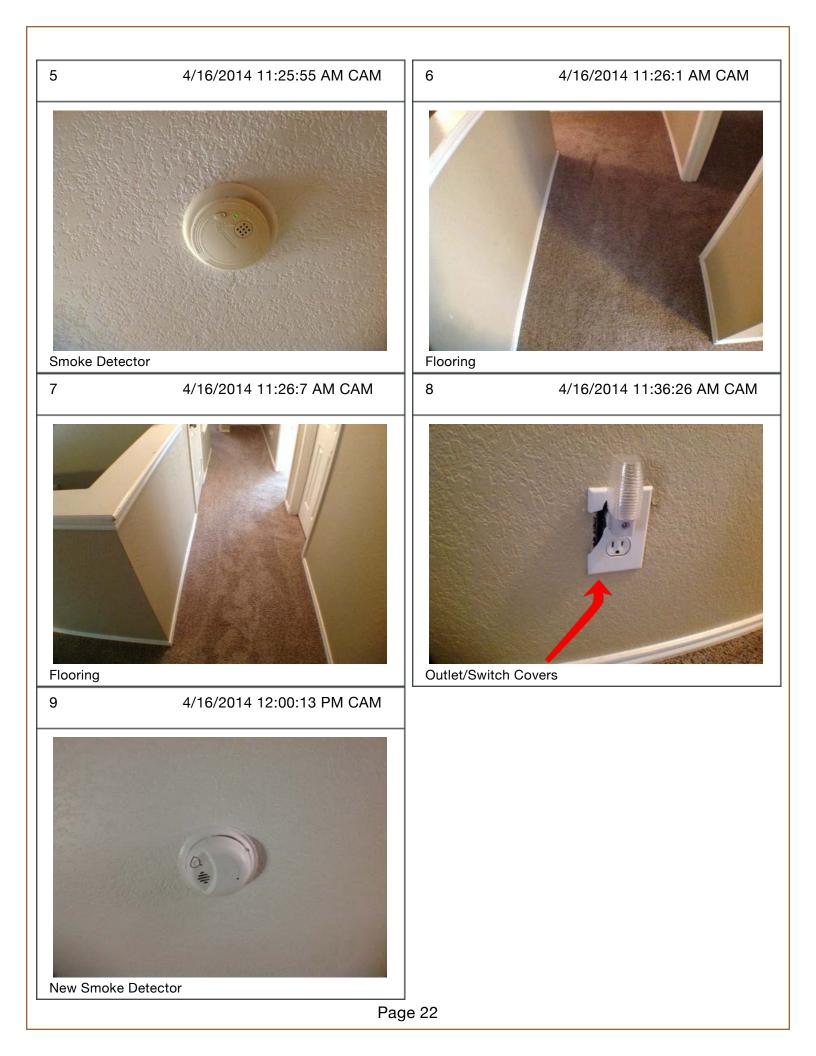
4 . Outlet/Switch Covers-Broken outlet cover in front of AC closet.

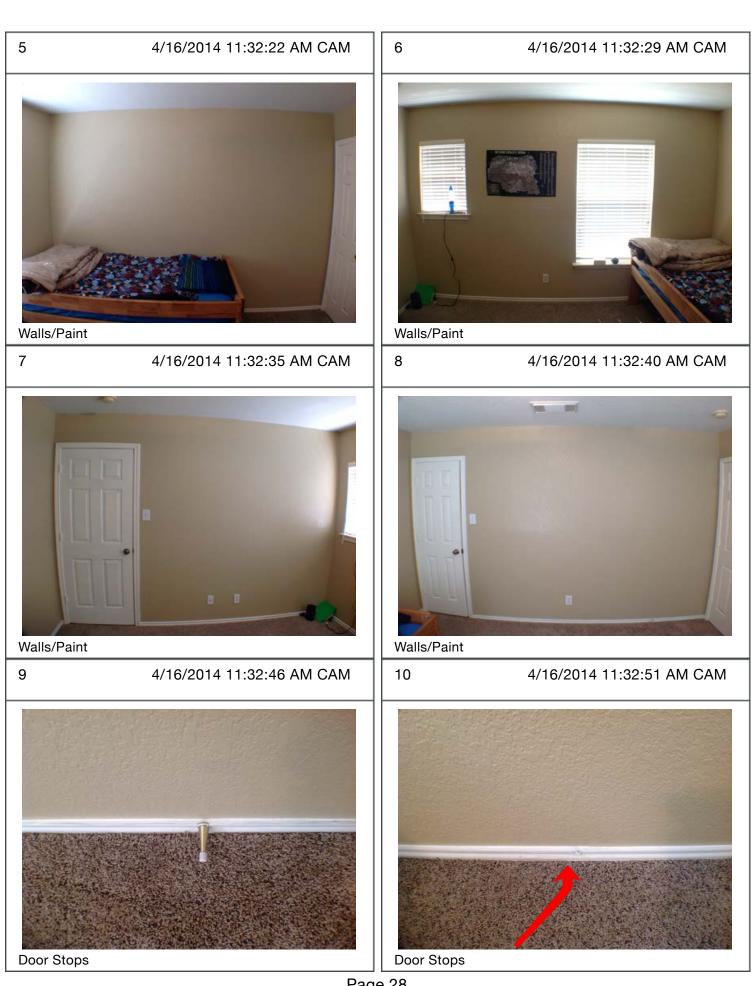
8 . Door Stops-Missing doorstop to Closet Door.

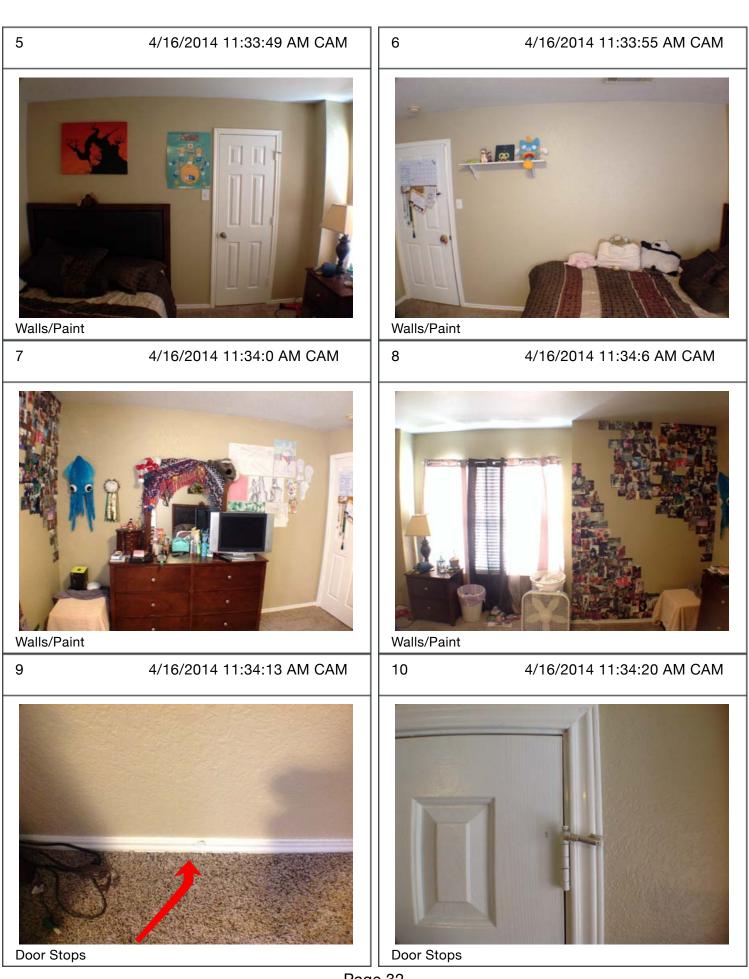
8 . Door Stops-Missing doorstop behind Bedroom door.

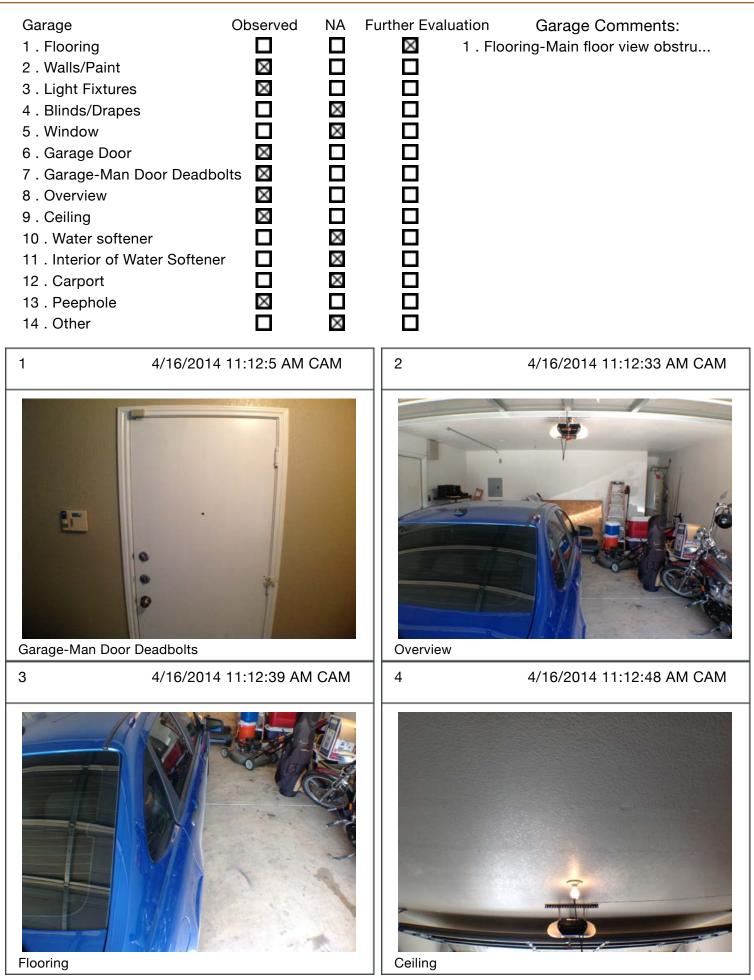
1 . Flooring-Main floor view obstructed by tenants vehicle.

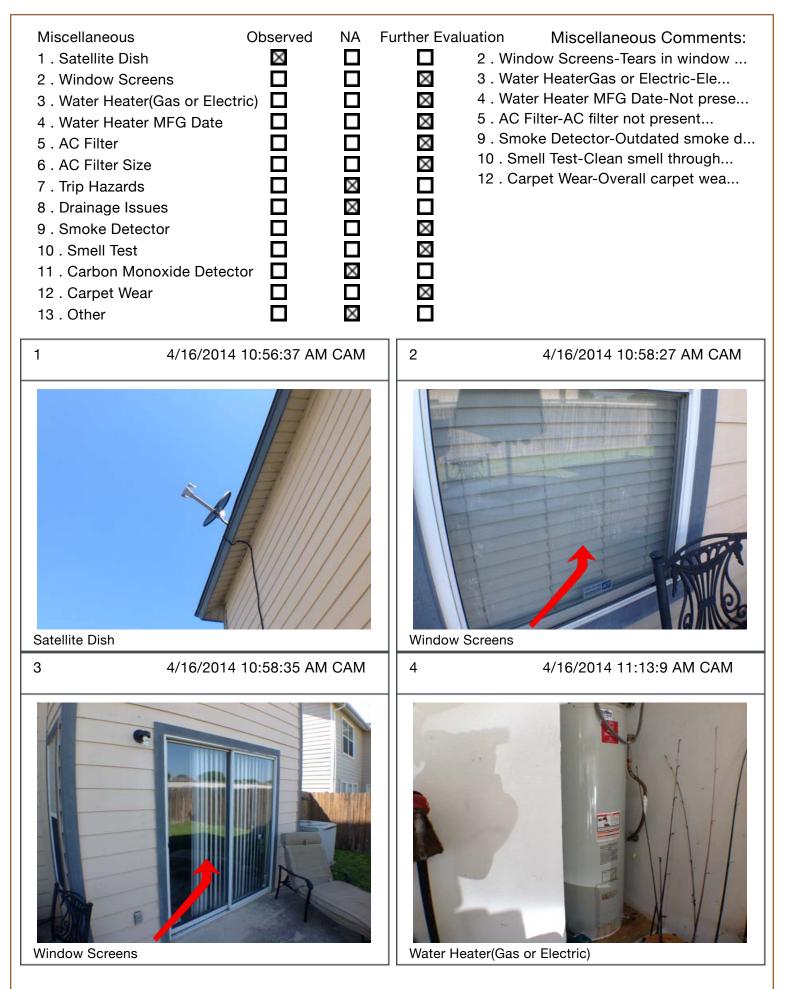
2 . Window Screens-Tears in window screen in lower left middle window on rear back wall. Missing screen door on rear sliding glass door.

5. AC Filter-AC filter not present in unit.

9. Smoke Detector-Outdated smoke detectors replaced by newly installed hard-wired units. Date on back of outdated units read the year 2002Jan08. All units are functional after testing with liquid smoke. Date on backs of new hard-wired units read 2014Feb24. Total of 6 units were installed.

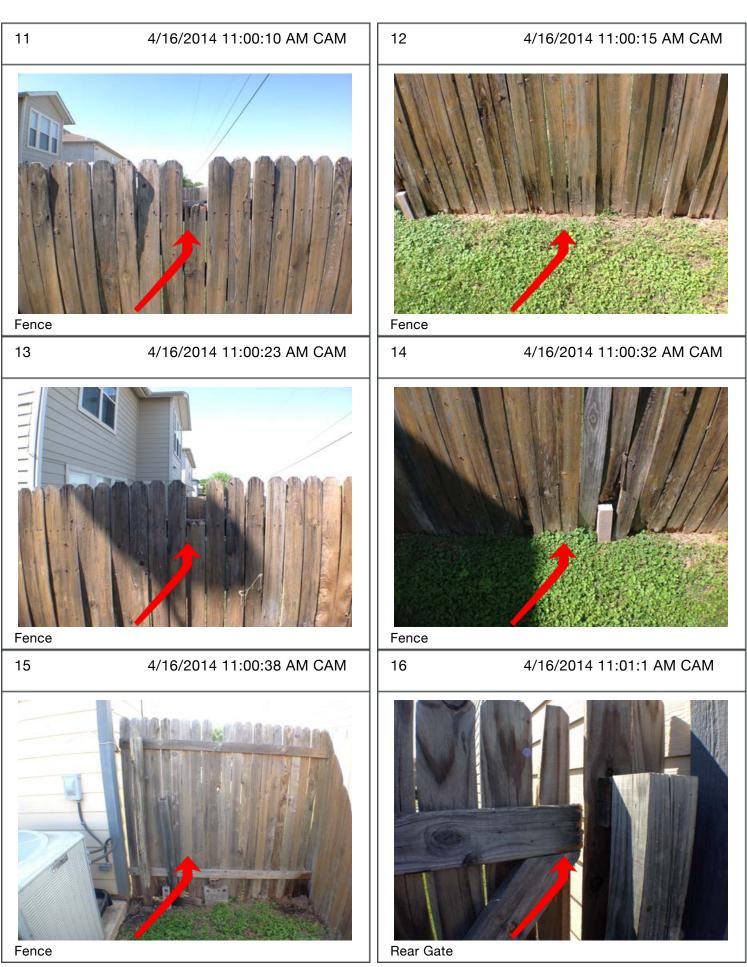
2 . Fence-Outward lean left side of rear right fence line. Slight inward lean right side of rear back fence line. Slight inward lean left side of rear back fence line. Inward lean right side of rear left fence line. Broken vertical wood slat right side of rear left fence line. Deterioration along bottom of right side wood slats on rear left fence lines broken vertical wood slats midsection of rear left fence line. Broken vertical wood slat left side of rear left fence line. Broken vertical wood slat on front left fence line.

9. Rear Gate-Rear gate on front right fence line does not close properly.
